Ports & Harbours Annual Return Form

BRIGHTLINGSEA HARBOUR COMMISSIONERS (BHC); EXERCISE NOVEMBER CHARLIE

Annual return for period 2019

EXERCISE HELD ON 20TH MARCH 2019

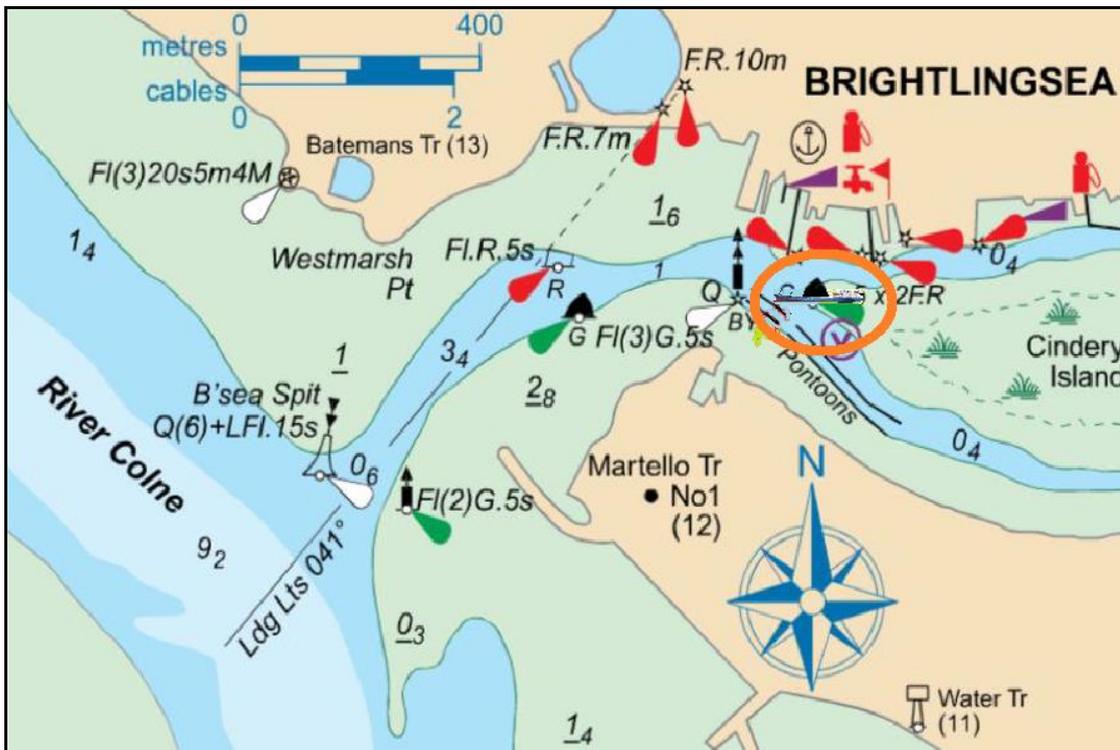
Overview of spill area

Location: Minters Point, Brightlingsea Harbour
Time: 1004
Date: 20 March 2019
Weather: Real weather
Tides: HW 1131 5.2m LW 1759 0.6m

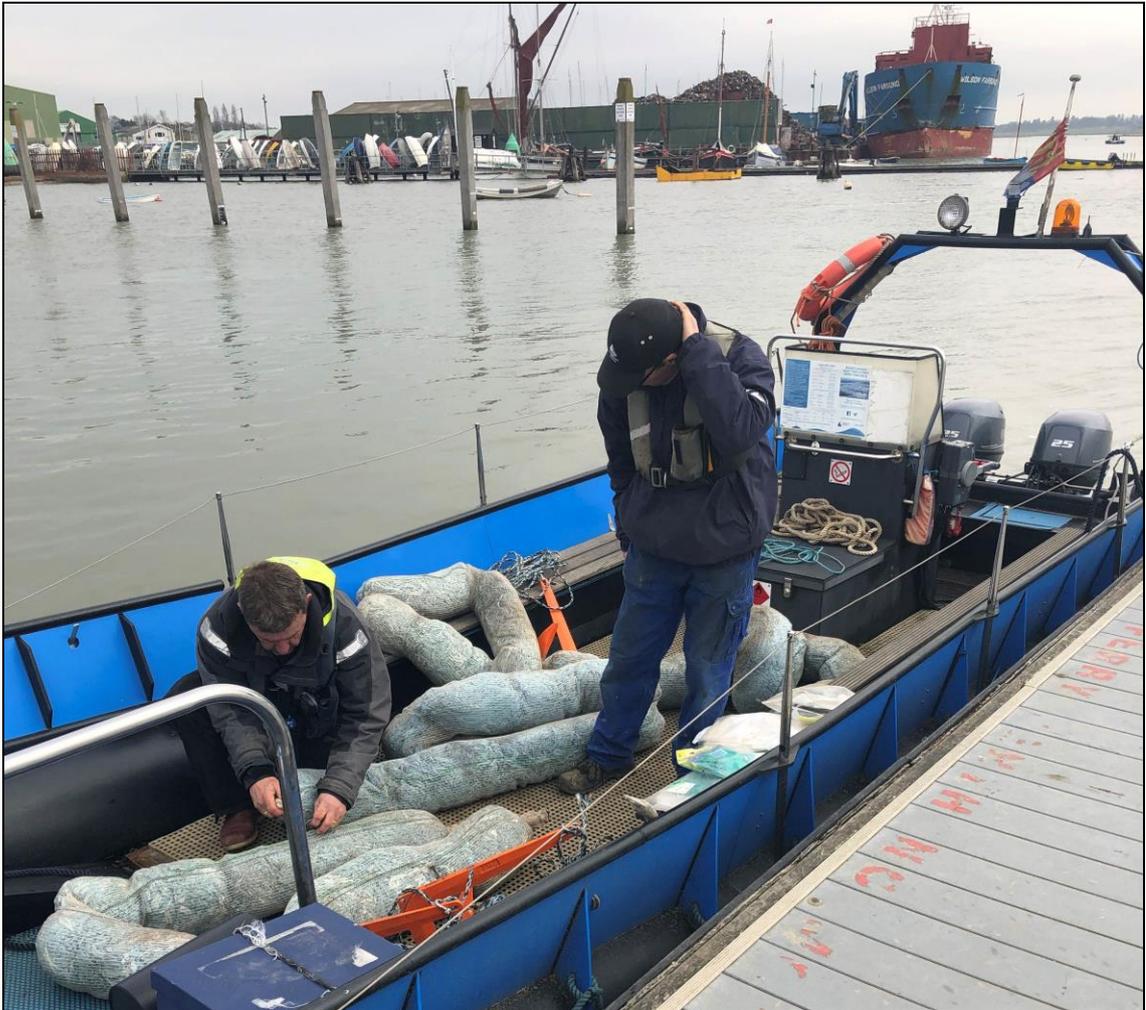
Photograph 5: Preparation of Tier 1 sorbent boom

life. Later on, a further Tier 1 sorbent boom was deployed around the other half of the vessel. This totalled two, 20m sorbent booms.

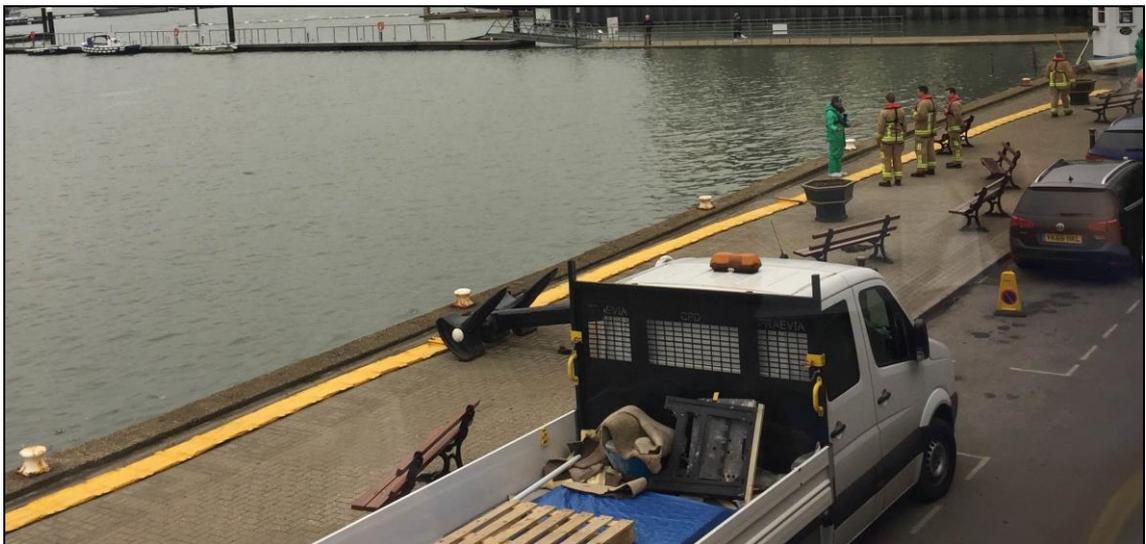
Photograph 10: Fence boom flaked for deployment

- The Tier 2 strategy was to line the jetty with 50P fence boom and then to use sea sentinel boom as a spur off the end of the jetty.
- The fence boom, 50m, deployment was highly effective and was deployed quickly with several responders assisting.

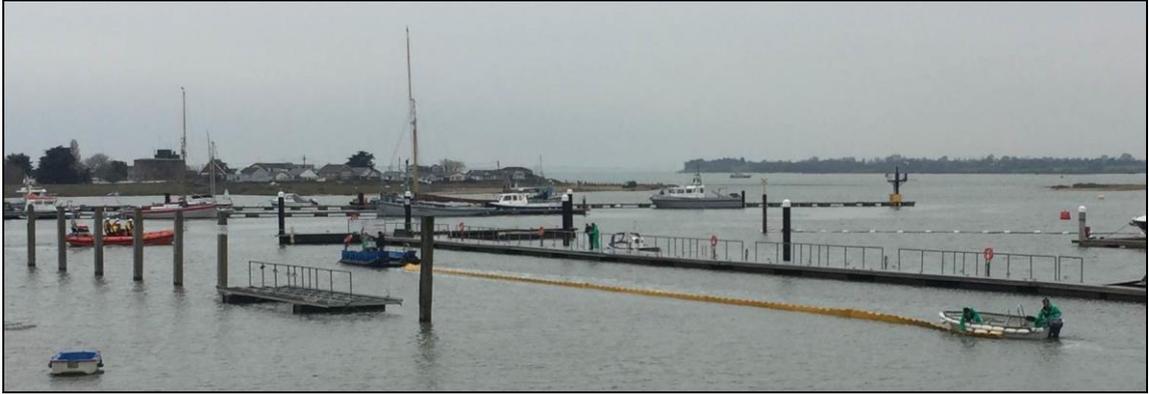
Photograph 11: Deployment of Tier 2 fence boom

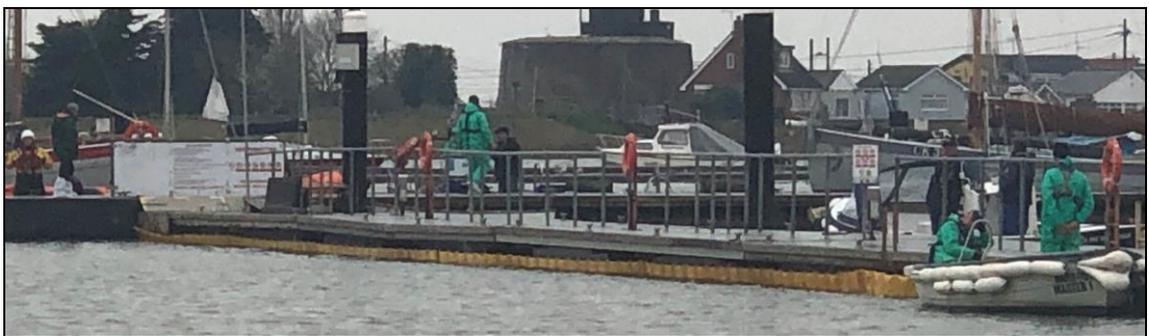
Photograph 12: Deployed Tier 2 fence boom

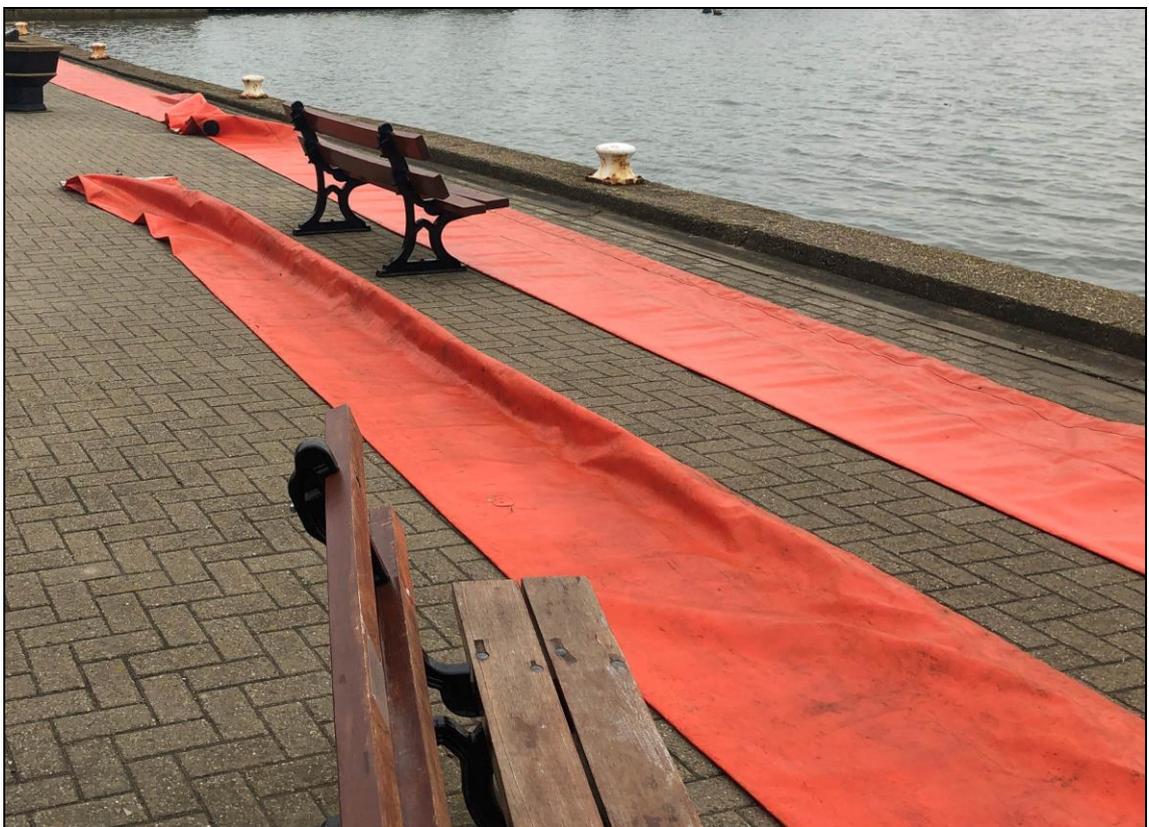
Photograph 13: Flaked Tier 2 sea sentinel for deployment

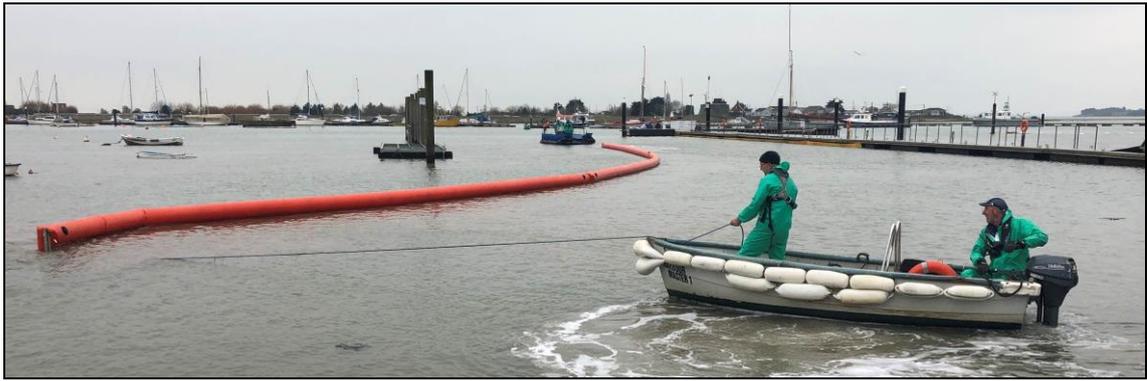
Photograph 14: Deployment of Tier 2 sea sentinel boom

- The spur boom, 60m, was not as successful as the flow rates were underestimated. Therefore this posed challenging to manoeuvre the boom into position and even once in position, product would have escaped the containment measure (entrainment) with the currents in the channel.

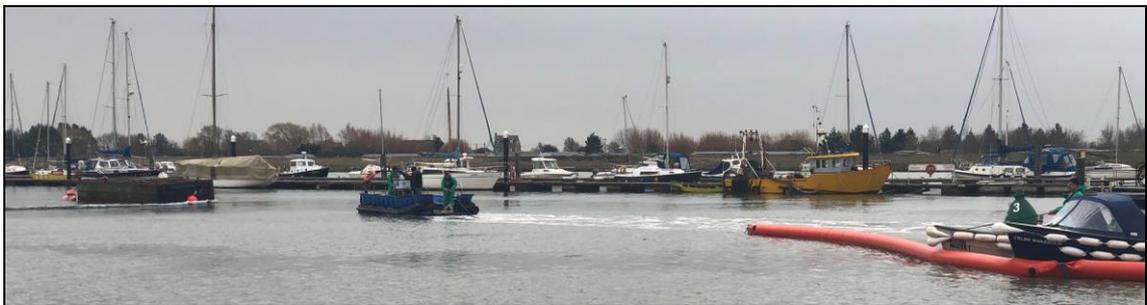
Photograph 15: Tier 1 sorbent boom (left) and difficulties with sentinel deployment against the current

- It should be remembered that booms are limited in respect to the angle against the current. Acuter angles allow for safer loads on the rope and for more effective booming.

- Another element which provided a lesson for future deployments was that anchors were not biting in the channel. This was not anticipated and the strategy had to be altered to anchor to lines already in place.

- The debrief session has provided a strategy to be tested at a future exercise, to keep the same fence boom but to deploy inflation boom between the town pontoon and the yacht club pontoon. This is more likely to catch product on the ebb.

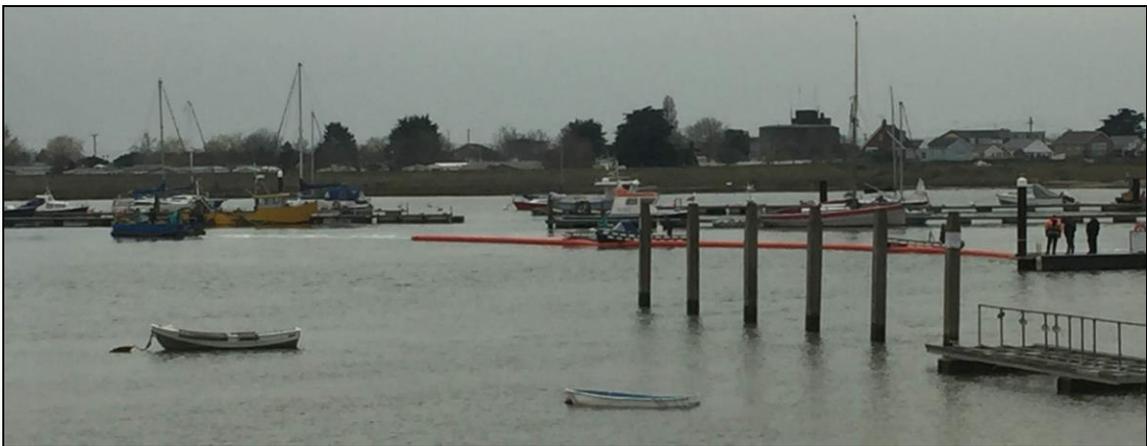
Photograph 16: Deployed sea sentinel boom
